# **Lightning and Surge Protection of Photovoltaic Installations**

## **Two Case Histories: Vulcano and Kythnos**

François D. Martzloff

**June 1989**

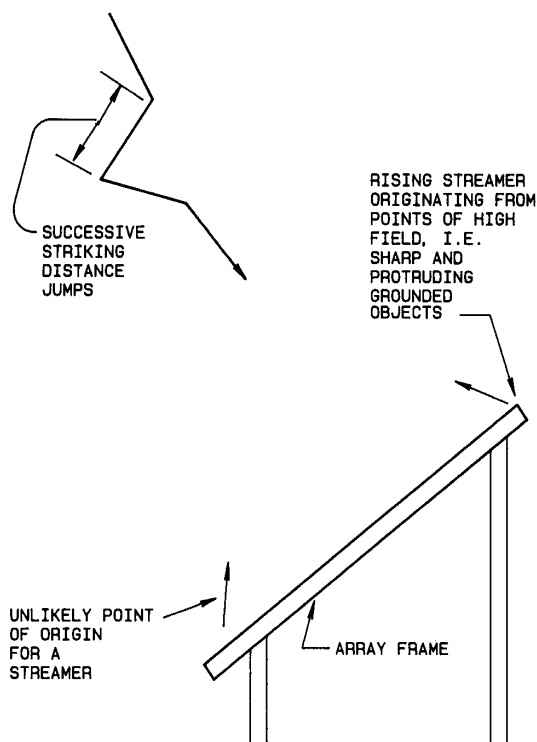
Figure 2-3. Descending stepped leader and rising streamer in a cloud-to-ground lightning strike

The damage to the module is located at the lower part of the array, as shown in Photograph 2-2. Postulating a scenario of a direct strike to the array, the point of attachment of the lightning would be the point of origin of the rising streamer that meets the descending stepped leader (Figure 2-3).

This position at the lower part of the array is rather unexpected for the point of initiation of the streamer. A more likely point for streamer initiation – and resulting termination of the strike – would be the upper edge of the array, which is 2 m above grade level (Photograph 2-15). Thus, there is some doubt on drawing a conclusion that the damage was the result of a direct strike terminating at the array.

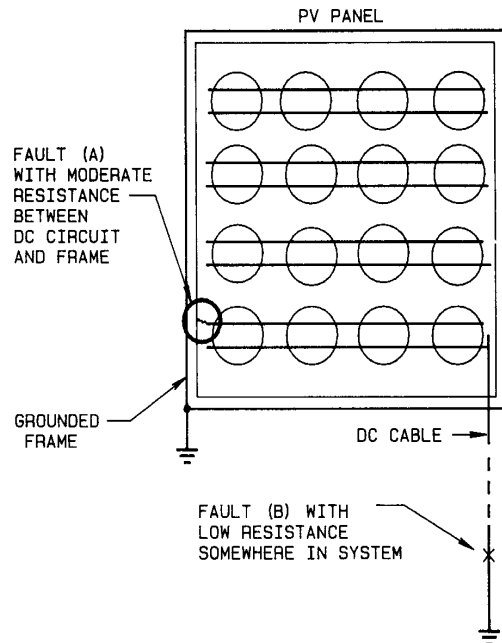
Figure 2-4. Scenario of double ground fault

In view of the reported insulation problems that occurred during the initial period of operation, one might ask whether the damage to that panel might be the result of a leakage of dc current to the frame, rather than the simple direct effect of a lightning strike. This dc leakage might be the consequence of a lightning induced overvoltage stress that created a double fault in one single event, or that created the second fault after the first had previously occurred but remained uncorrected. The scenario could unfold as follows:

In this manner, we have the elements that could create the observed effects, that is, an obvious fault with burning at (A), and a less obvious fault at (B), with a low resistance that may be eliminated during emergency maintenance work following the occurrence of the incident. The likelihood of such a double fault is admittedly low, but cannot be ruled out in view of the design of the ground fault detection system which indicates faults locally only. This scenario, still associated with lightning, would not be in contradiction with the observed low position of the damage since it does not require termination of the strike at that low point of the panel. Furthermore, the low point on the sloped array is also a place where moisture is more likely to accumulate and thus create a good candidate for a contributing cause in the scenario of two-stage insulation breakdown.

A variation on the theme of the double fault might even be that the fault was entirely caused by long-term insulation breakdown, without the “*coup de grace*” administered by the lightning incident. However, the observation of a damaged module soon after a lightning storm would point to the lightning-induced overvoltage scenario.

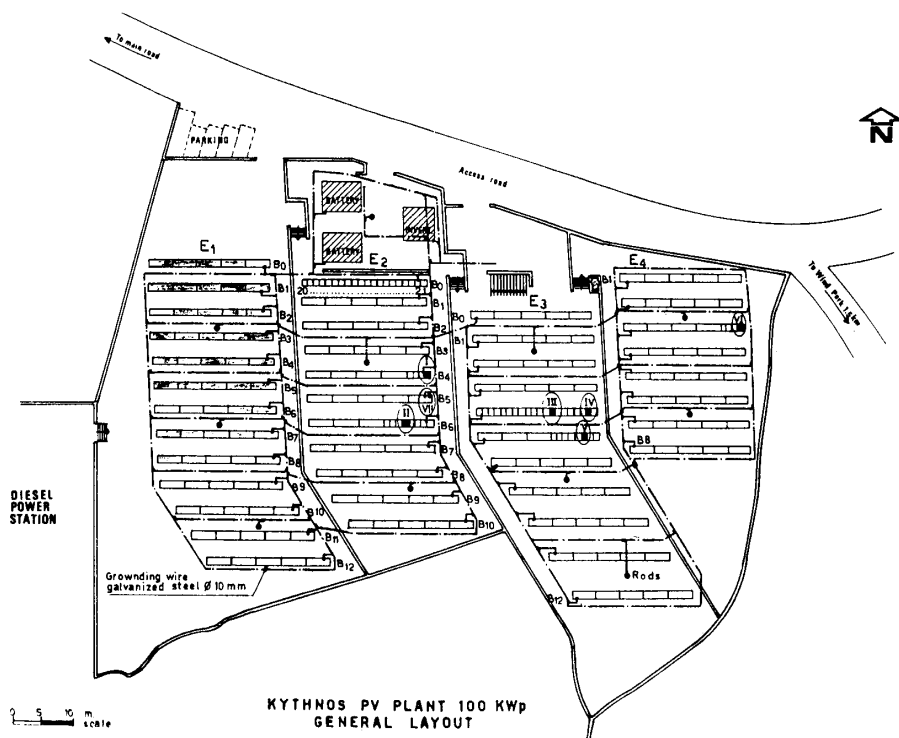
Figure 3-2. Location of ground cables, air terminals, and modules presumed damaged by lightning

Thus, five of the six damaged modules were beyond the 45° cone, and the sixth was on the fringe of the cone. Some panels in the array, not impacted by lightning, are further away from an air terminal, the greatest distance in the field being 15 meters. Another interesting statistic is the distribution of the panels with respect to being within a protected area of 8.5 meters radius (approximately 75%) or outside the protected area (25%).

**MODULE - 307 0423** This module was in storage and had been at location E2 B4 1 ("I" on Figure 3-2), 10 m from the nearest air terminal. There are burn marks along both long edges,

**MODULE - 303 0267** This module was in storage and had been at location E3 B5 18 ("V" on Figure 3-2), 8 m from the nearest air terminal. There are burn marks along both vertical edges, but not over the complete length (Photograph 3-20). On the right side, the burns are mostly at the upper part of the module, with damage at both corners (Photographs 3-21 and 3-22). The top right corner (Photograph 3-21) shows heavy burn marks on the frame, while the top left corner (Photograph 3-23) shows light marks on the frame. It should be noted that this module, which has the heaviest burn marks on its frame among the six modules, is the only module that was located within the "cone of protection" of an air terminal. This remark will be discussed further in the next section.

**MODULE - 304 0294** This module was in storage and had been at location E3 B5 19 ("IV" on Figure 3-2), 12 m from the nearest air terminal. There are burn marks along all of the right side, and part of the left side (Photograph 3-24). Both top corners show damage (Photographs 3-25 and 3-26). The top right corner (Photograph 3-25) shows light burn marks on the frame, while the top left corner (Photograph 3-26) hardly shows any burn marks on the frame. There is extensive separation of the panel from the frame along the right side (Photograph 3-27)

**MODULE - 304 0300** This module is still in the array at location E3 B4 13 ("III" on Figure 3-2), 10 m from the nearest air terminal, and was found damaged on February 5, 1987. The bypass diode in the string allows the array to remain operational. There is damage on three of the corners and some of the edges (Photographs 3-31, 3-32, and 3-33), but the heaviest damage is on the lower left corner (Photograph 3-34). The two upper corners show surface degradation on the frame, but these do not appear to be burn marks (Photographs 3-32 and 3-33).

**MODULE - 310 0592** This module is still in the array at location E4 B3 20 ("VI" on Figure 3-2), 10 m from the nearest air terminal, and was found damaged on February 25, 1988. The bypass diode in the string allows the array to remain operational. The damage is concentrated on the left edge of the module (Photographs 3-35 and 3-37). The panel is separated from the frame (Photograph 3-38). The apparent discoloration of the frame at the top left corner does not seem attributable to burns (Photograph 3-36).

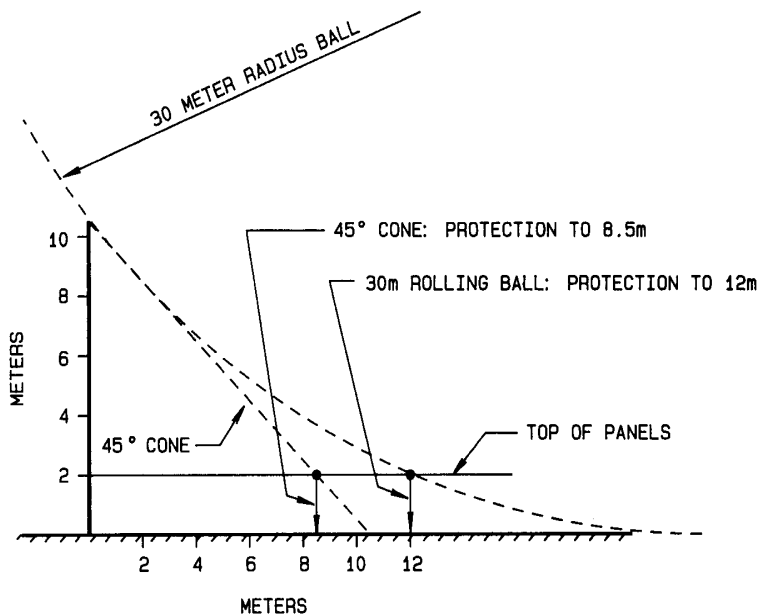
Figure 3-6. Cone-of-protection and rolling-ball criteria

Indiscriminate application of the 45° cone of protection criterion to tall structures has led to contradictions. An example is occurrence of lightning strikes terminating on the side of tall buildings, within the cone of "protection". The original concept of a cone of protection is now generally replaced by the rolling ball criterion, based on the striking distance theory. According to this striking distance theory [6], the striking distance at the tip of the descending stepped leader increases with the amount of charge in the leader. Thus, the leaders having the highest potential current level have the longest striking distance (Figure 3-4). Conversely, leaders having the lowest potential current level have the shortest striking distance. The point of termination of a lightning strike can be anywhere within the striking distance from the last point of advance of the descending stepped leader. This fact can be represented by imagining a sphere with a radius equal to the striking distance, which is determined by the charge in the lower part of the leader. Any point at ground potential penetrating that sphere is a candidate for emitting an upward streamer that will complete the path for the return stroke. Thus, points at ground potential outside of the sphere are still "protected" while the points inside the sphere are not.

Considering now the configuration of a vertical mast on the ground plane (Figure 3-5), rolling a ball on the ground until it touches the tip of the ball defines the limiting condition when the descending leader will terminate at the tip of the mast, thus leaving other points below the sphere uninvolved. Figure 3-6 shows
